GROUND AND MINING INVESTIGATION AT THE PROPOSED GLYNCOED PRIMARY SCHOOL, EBBW VALE

Ground Investigation Interpretative Report

Report No. Q0215/IR

September 2020

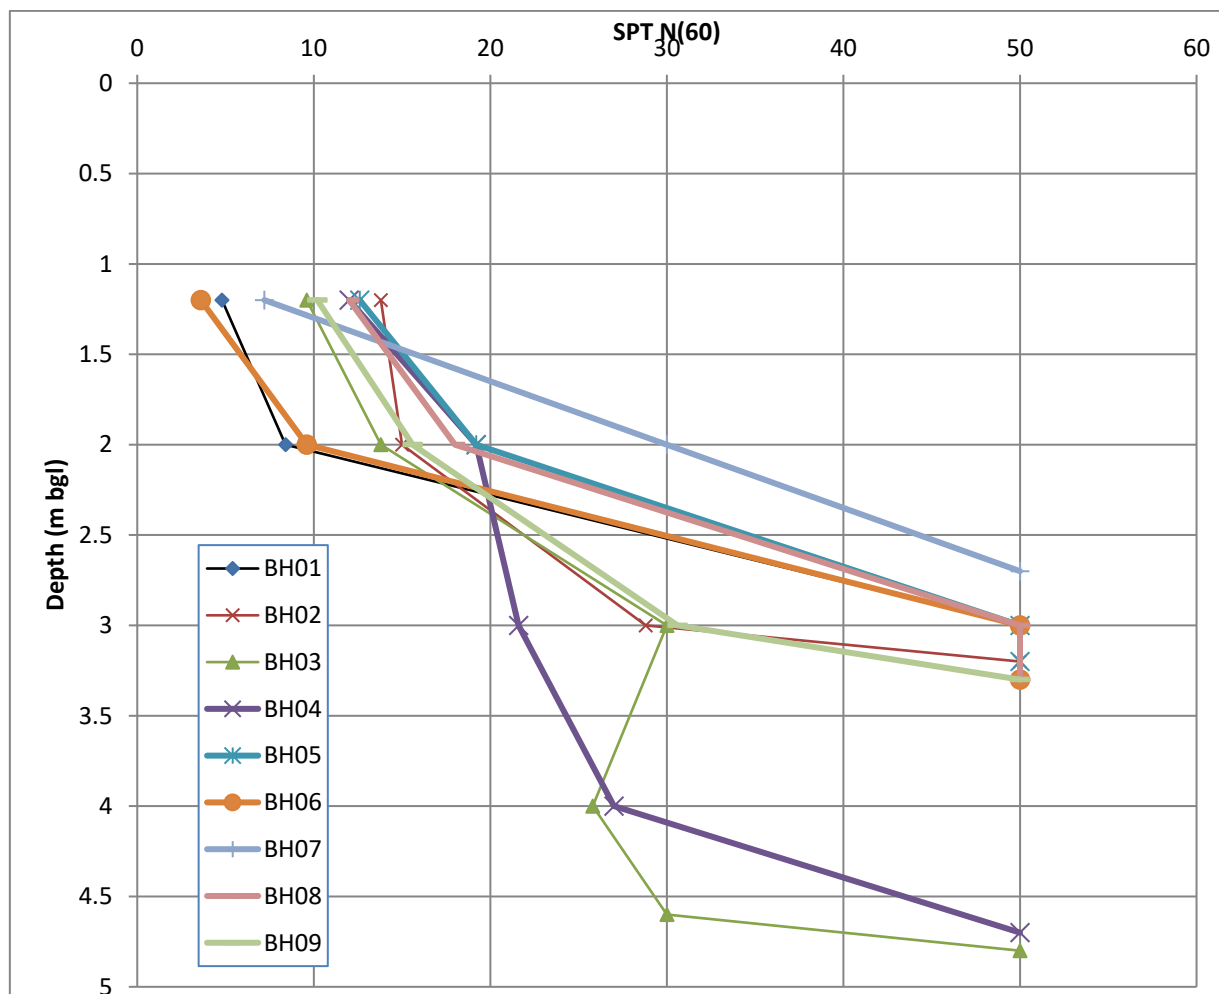
Figure 2: Summary of corrected (N₆₀) SPT results v Depth

Results of the in situ SPT tests were corrected (to N₆₀ values) using the equipment's energy ratio (E_r) found on their corresponding calibration certificates (in accordance with BS EN ISO 22476-3) and the N₆₀ values against depth are presented as Figure 2.

SPT tests undertaken within the Reworked Natural Ground measured SPT 'N' values of between 16 and 50+. It should be noted high SPT 'N' values may be due to encountering cobbles or boulders during the test, potentially resulting in elevated 'N' values.
